REPORT NUMBER: NCAP-MGA-2011-065

**NEW CAR ASSESSMENT PROGRAM (NCAP)
Frontal Barrier Impact Test**

**TOYOTA MOTOR MANUFACTURING, CANADA, INC.
2011 Toyota Corolla 4-Dr Sedan
NHTSA No.: MB5108**

FINAL REPORT

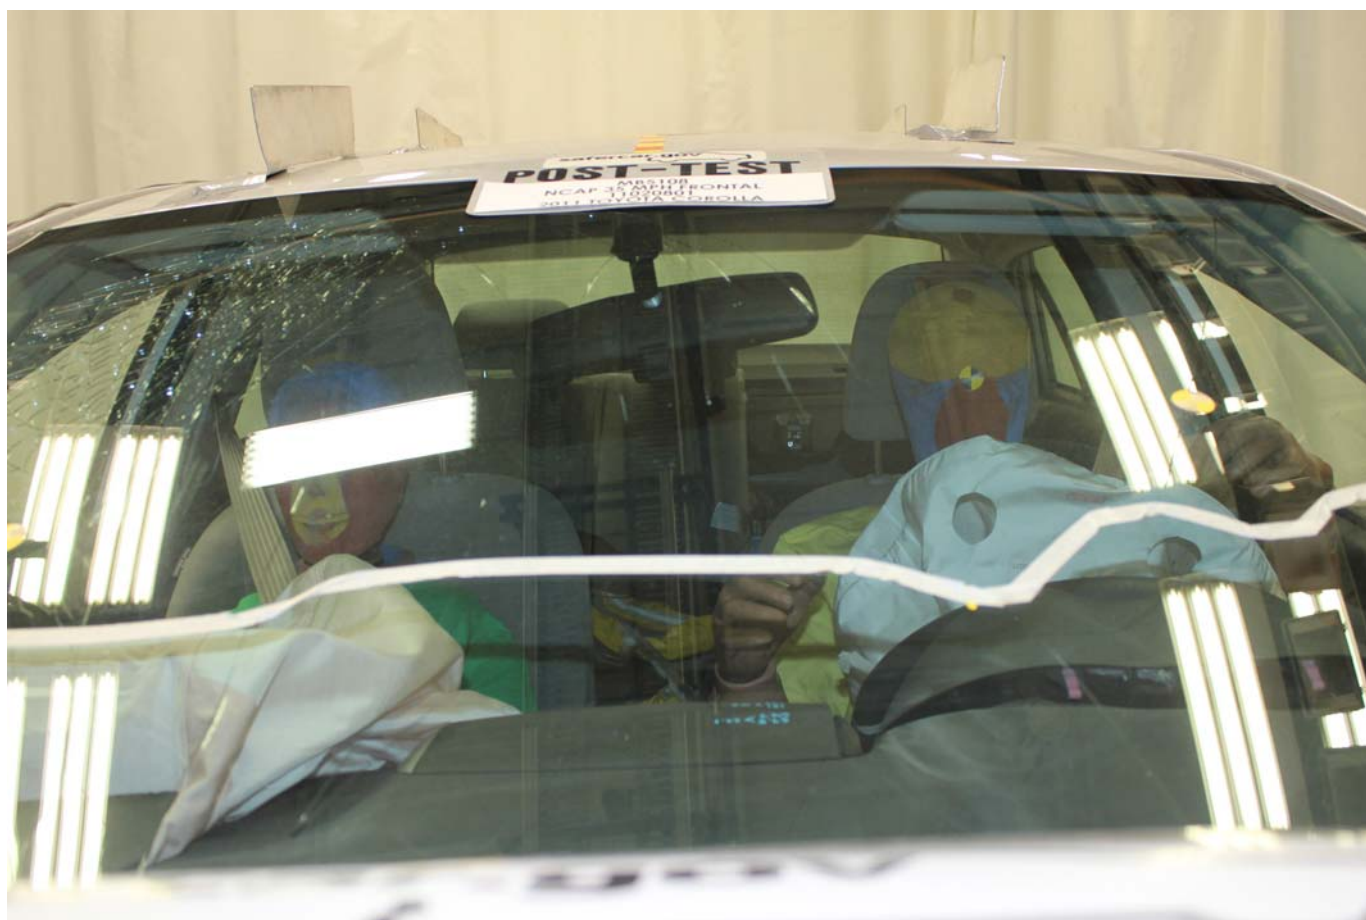
Post-Test Windshield View

There was 100 percent windshield retention and no intrusion into the protected zone of the windshield during the event. There was no Stoddard Solvent leakage after the event or during any phase of the static rollover.

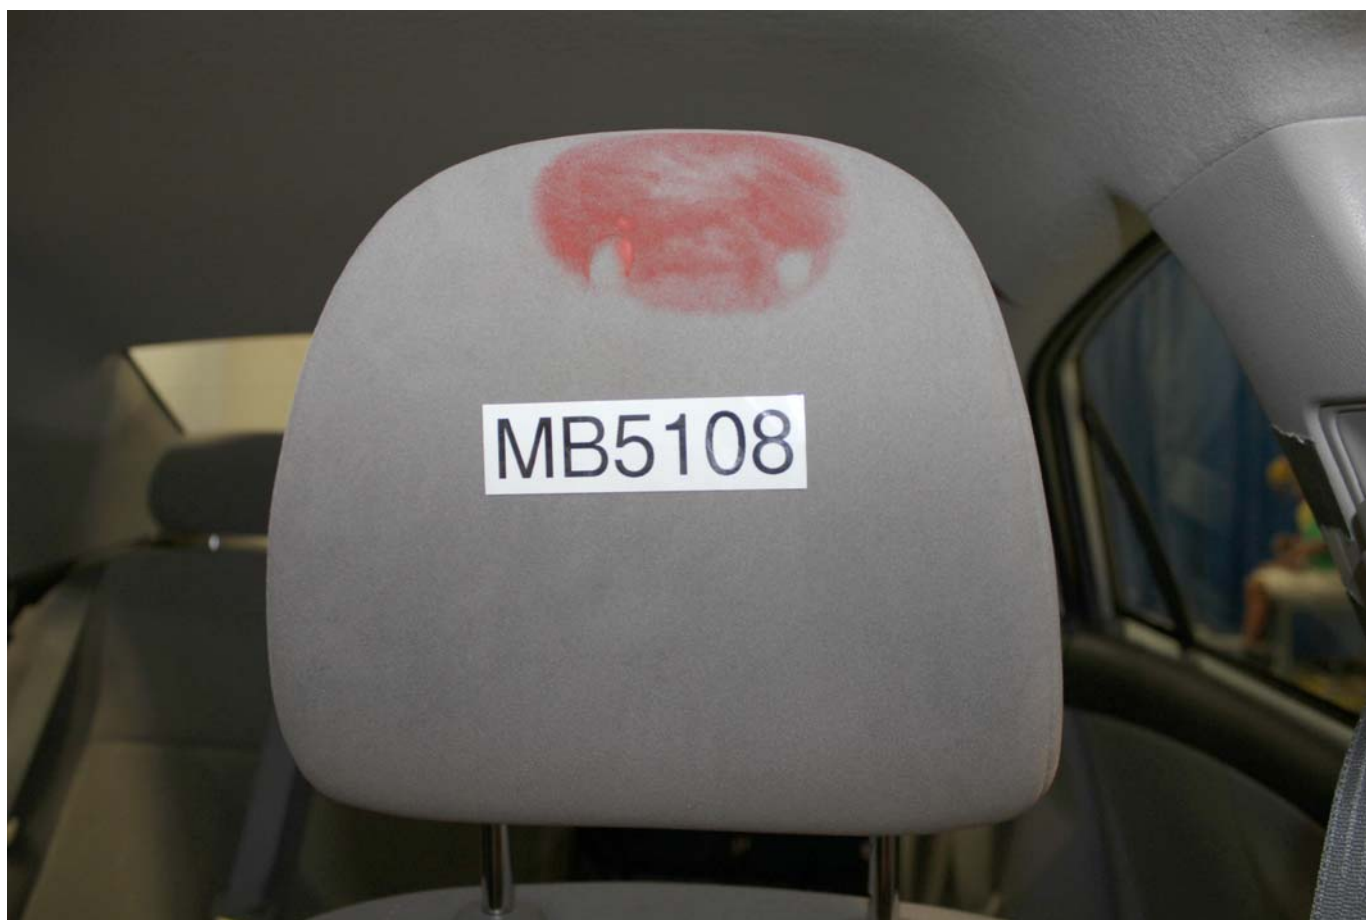
Post-Test Driver Dummy Contact with Headrest

The driver's head and chest contacted the airbag. The driver's head also contacted the headrest and headliner. The driver's knees contacted the knee bolster. The passenger's head and chest contacted the airbag. The passenger's head also contacted the headrest. The passenger's knees contacted the glovebox.

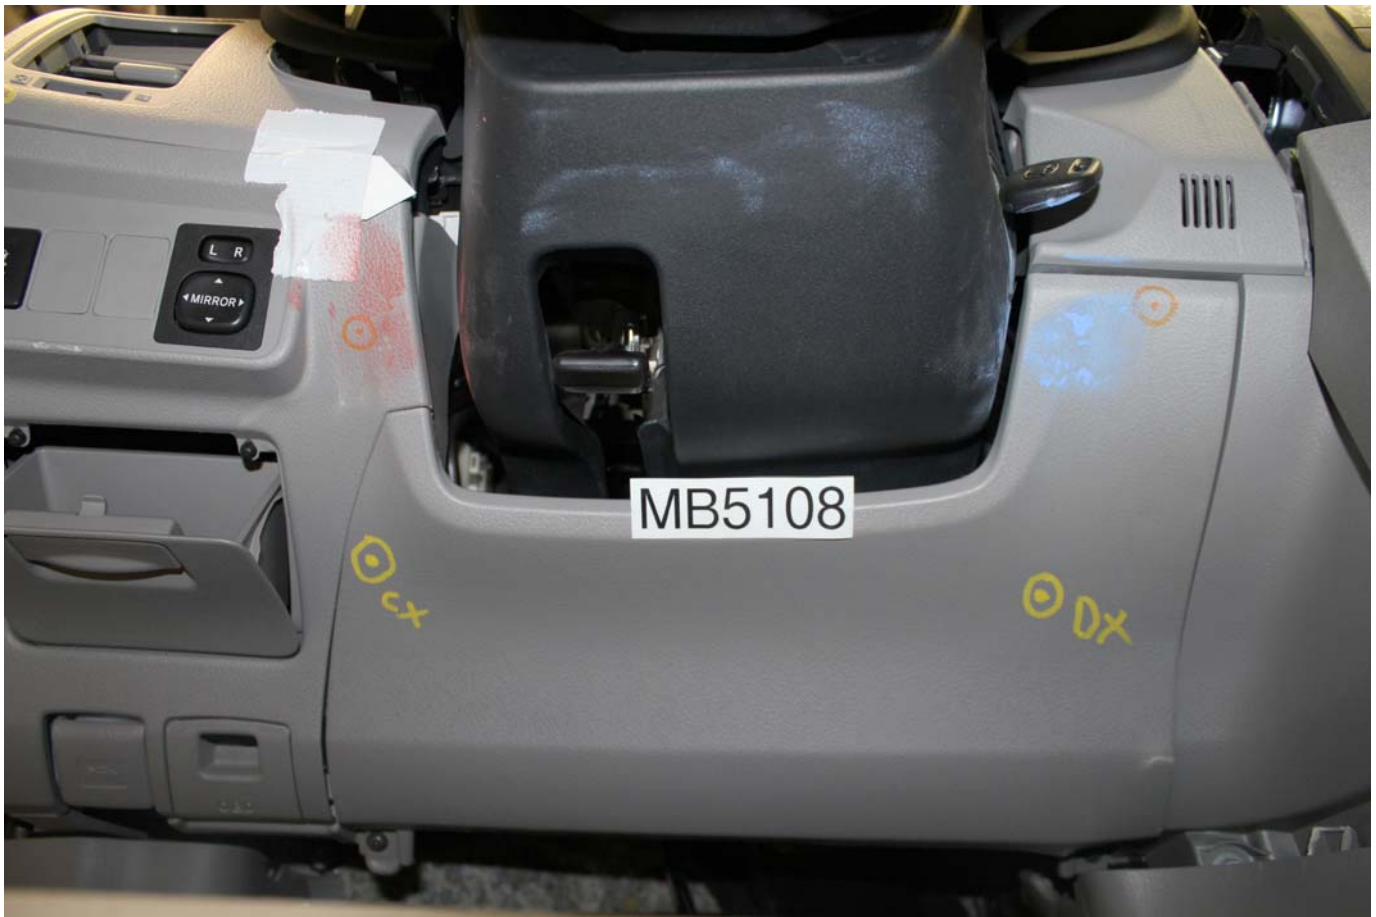
Post-Test Driver Dummy Contact with Knee Bolster

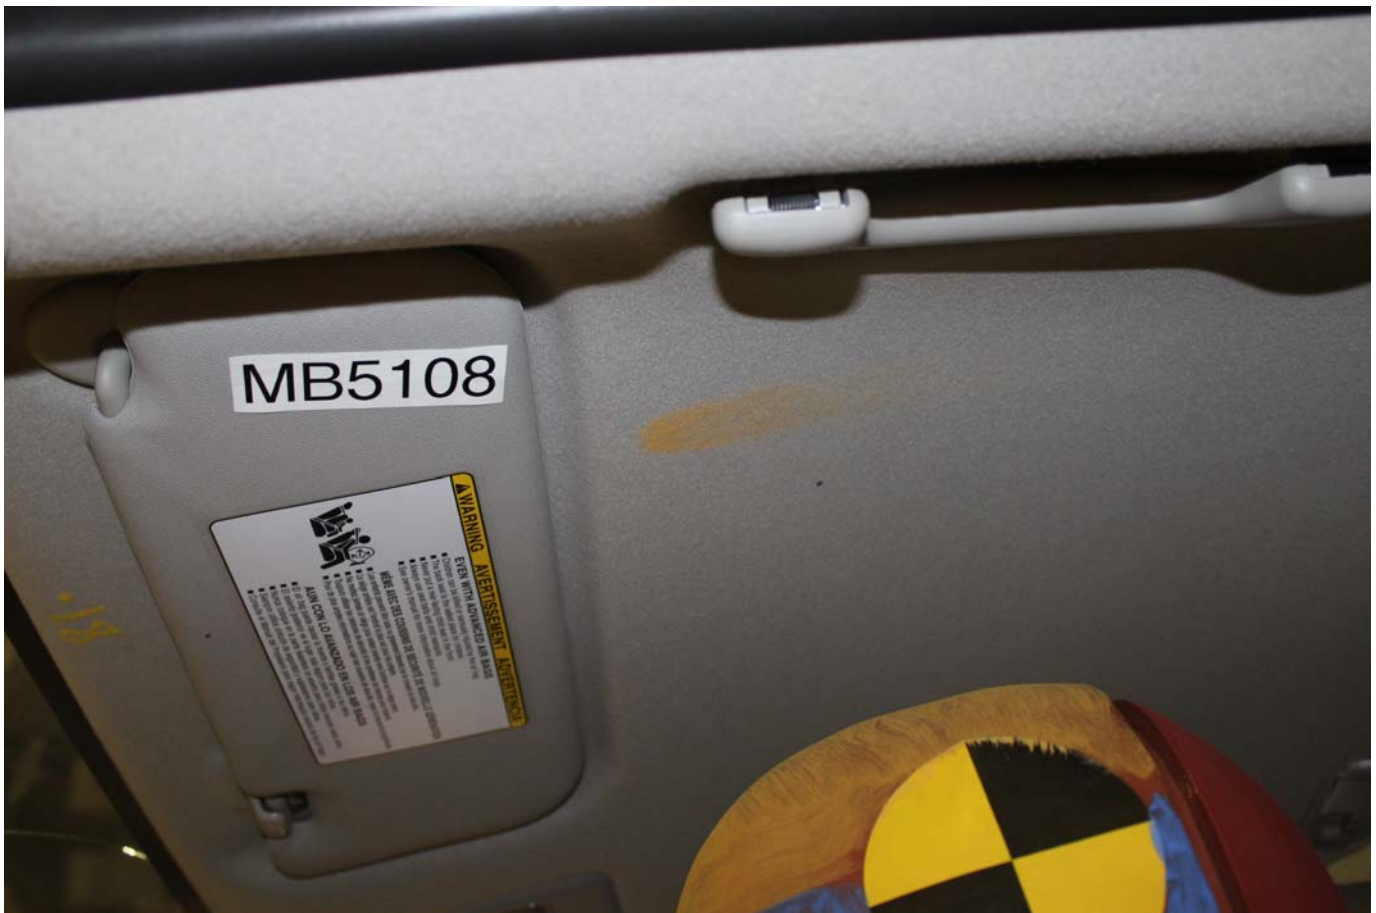
Post-Test Driver Dummy Contact with Headliner

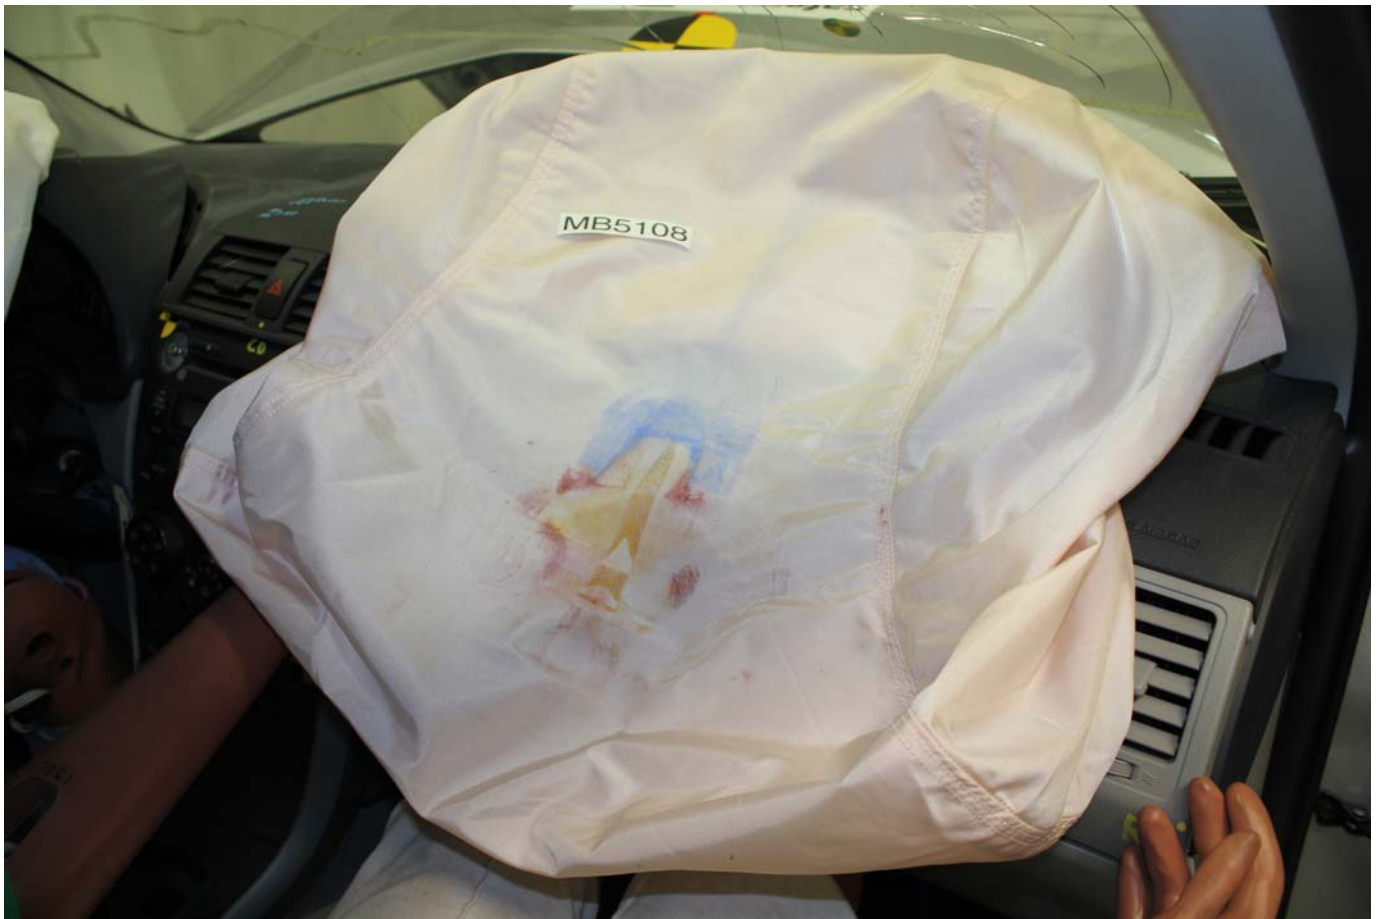
Post-Test Passenger Dummy Contact with Airbag

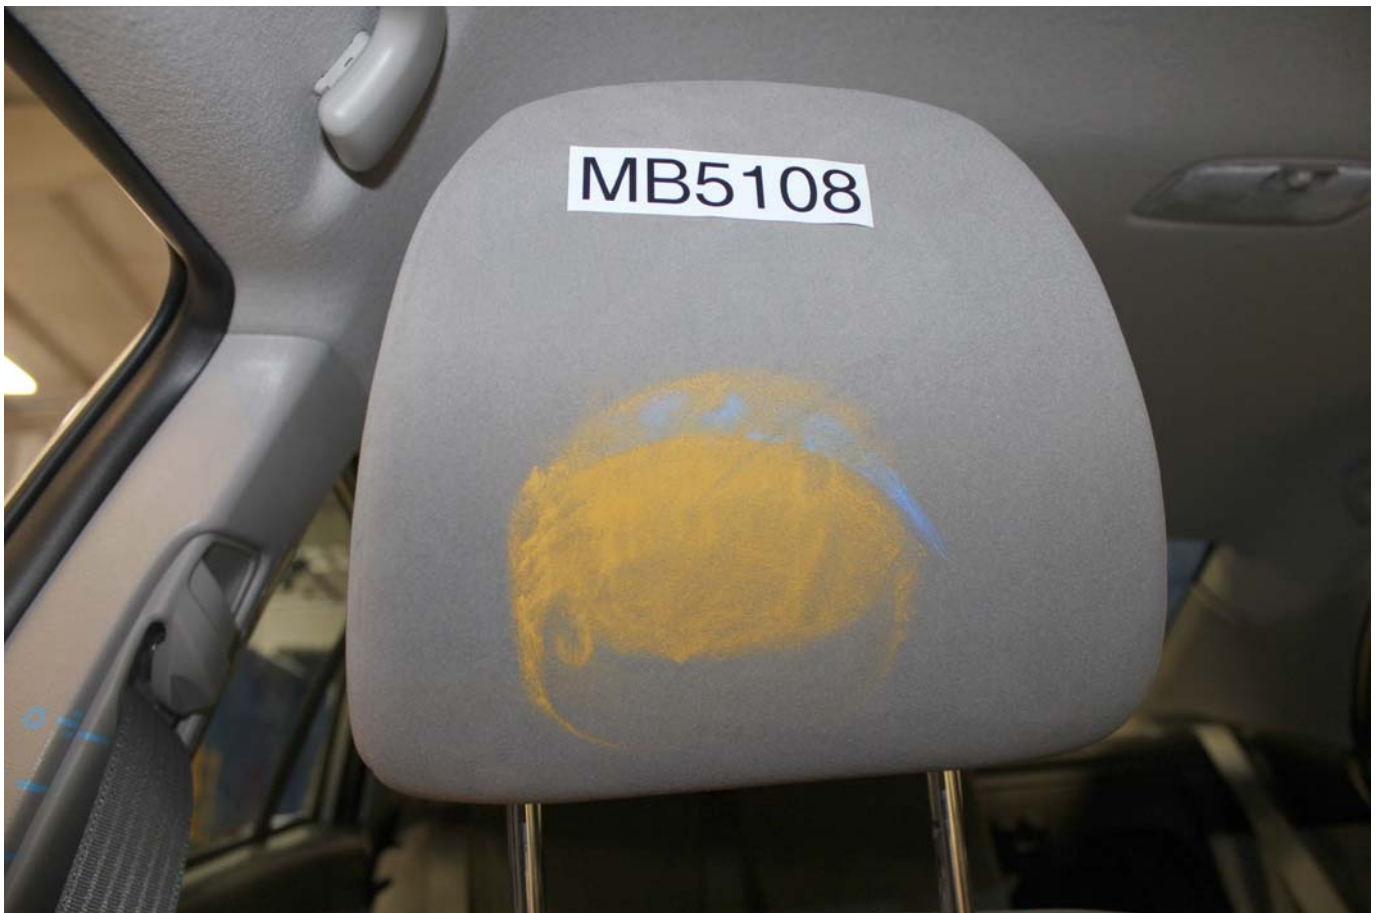
Post-Test Passenger Dummy Contact with Headrest

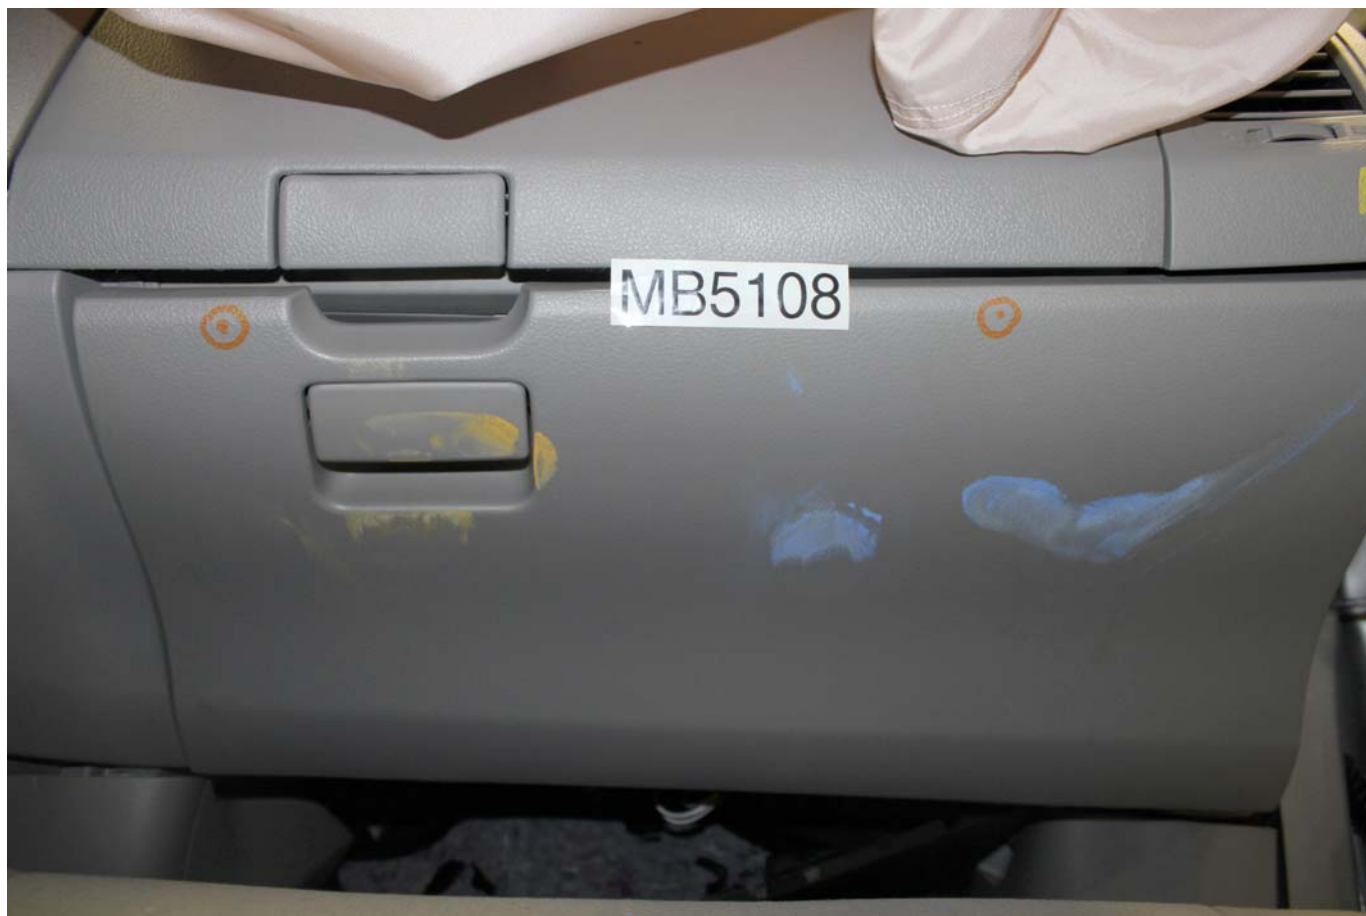
Post-Test Passenger Dummy Contact with Glovebox

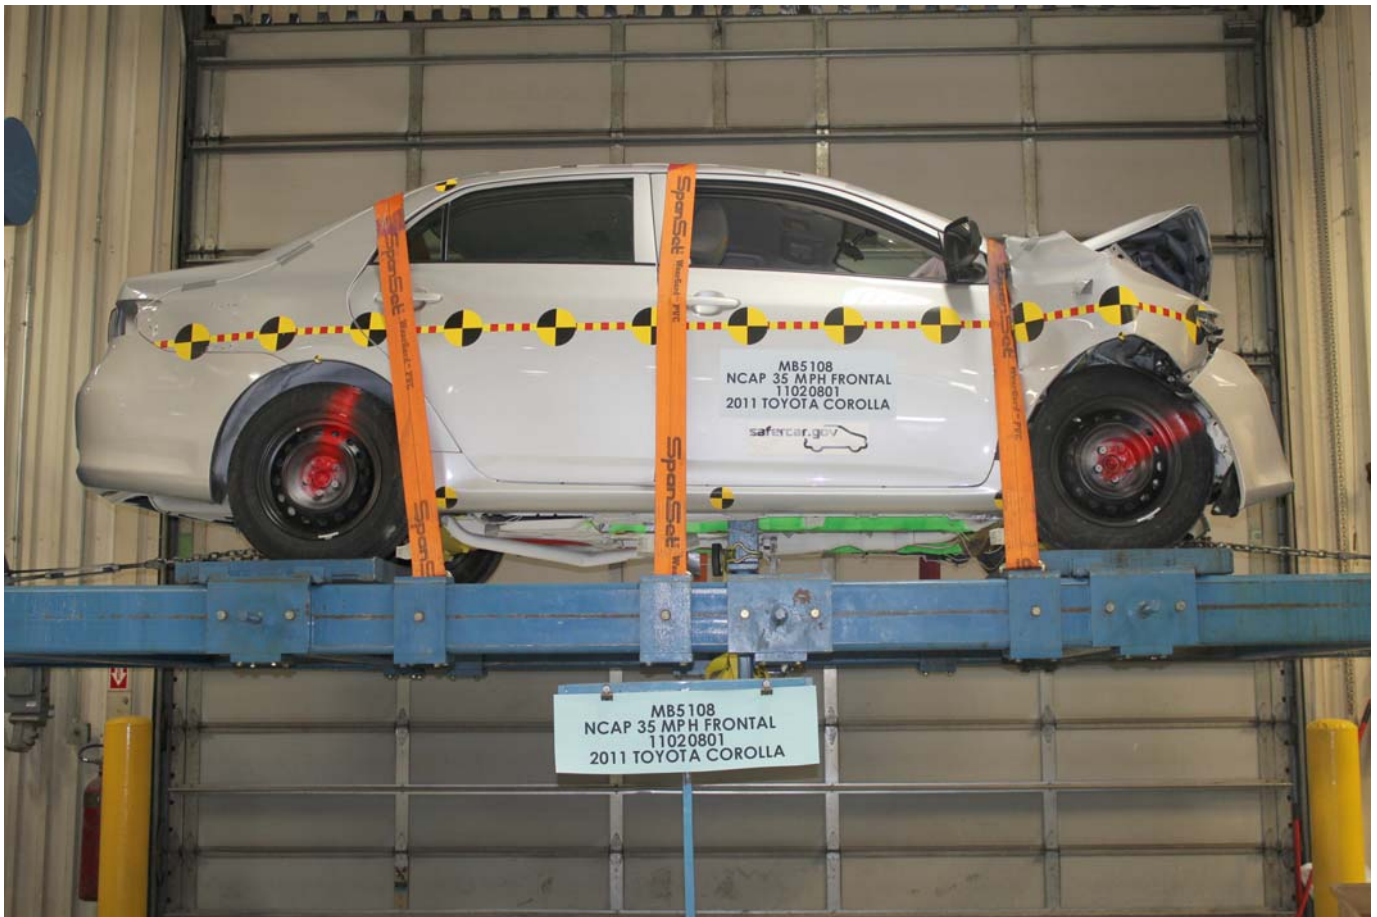
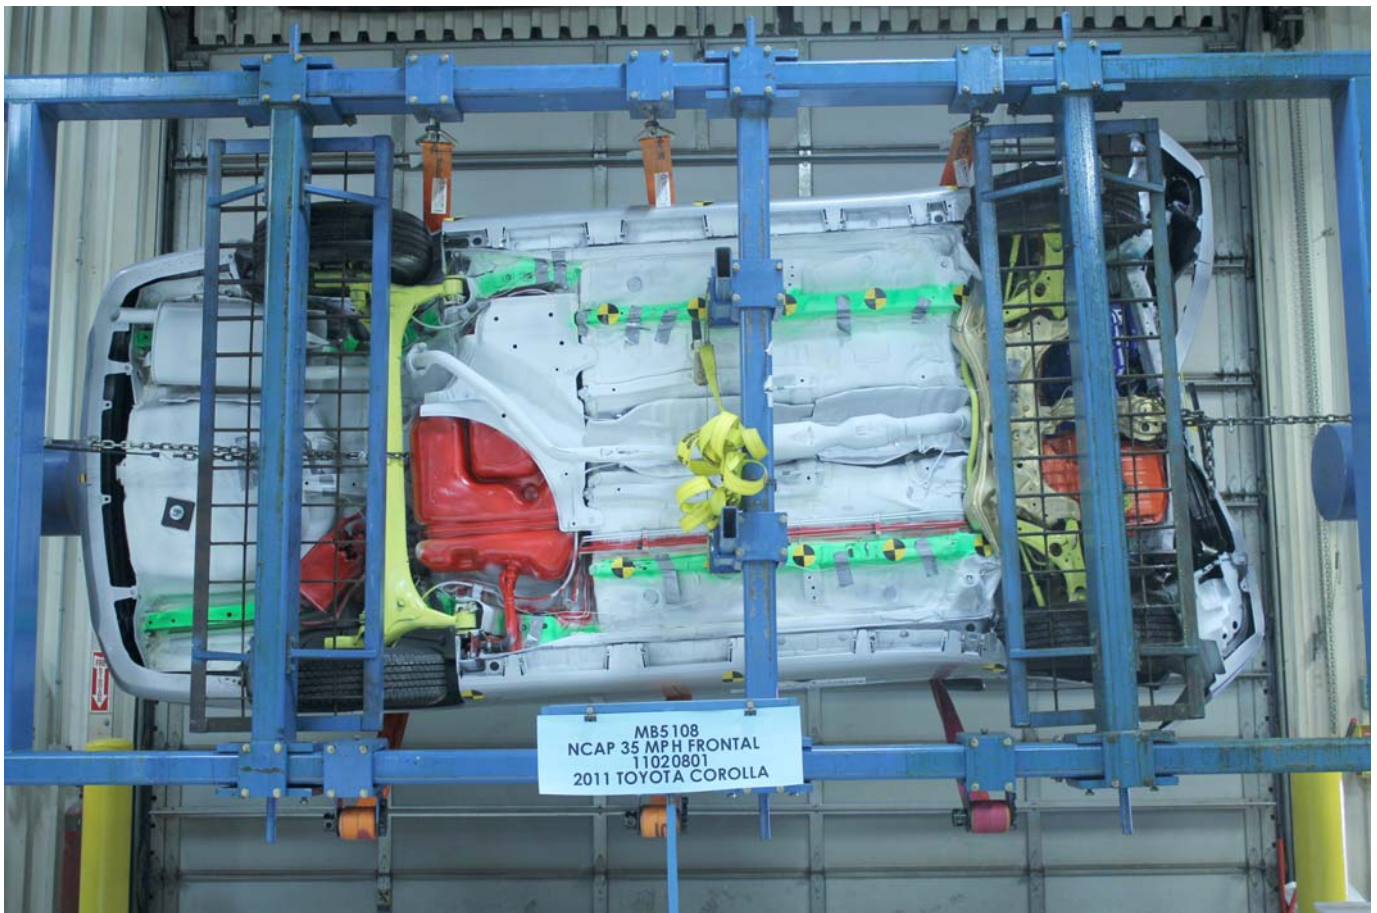
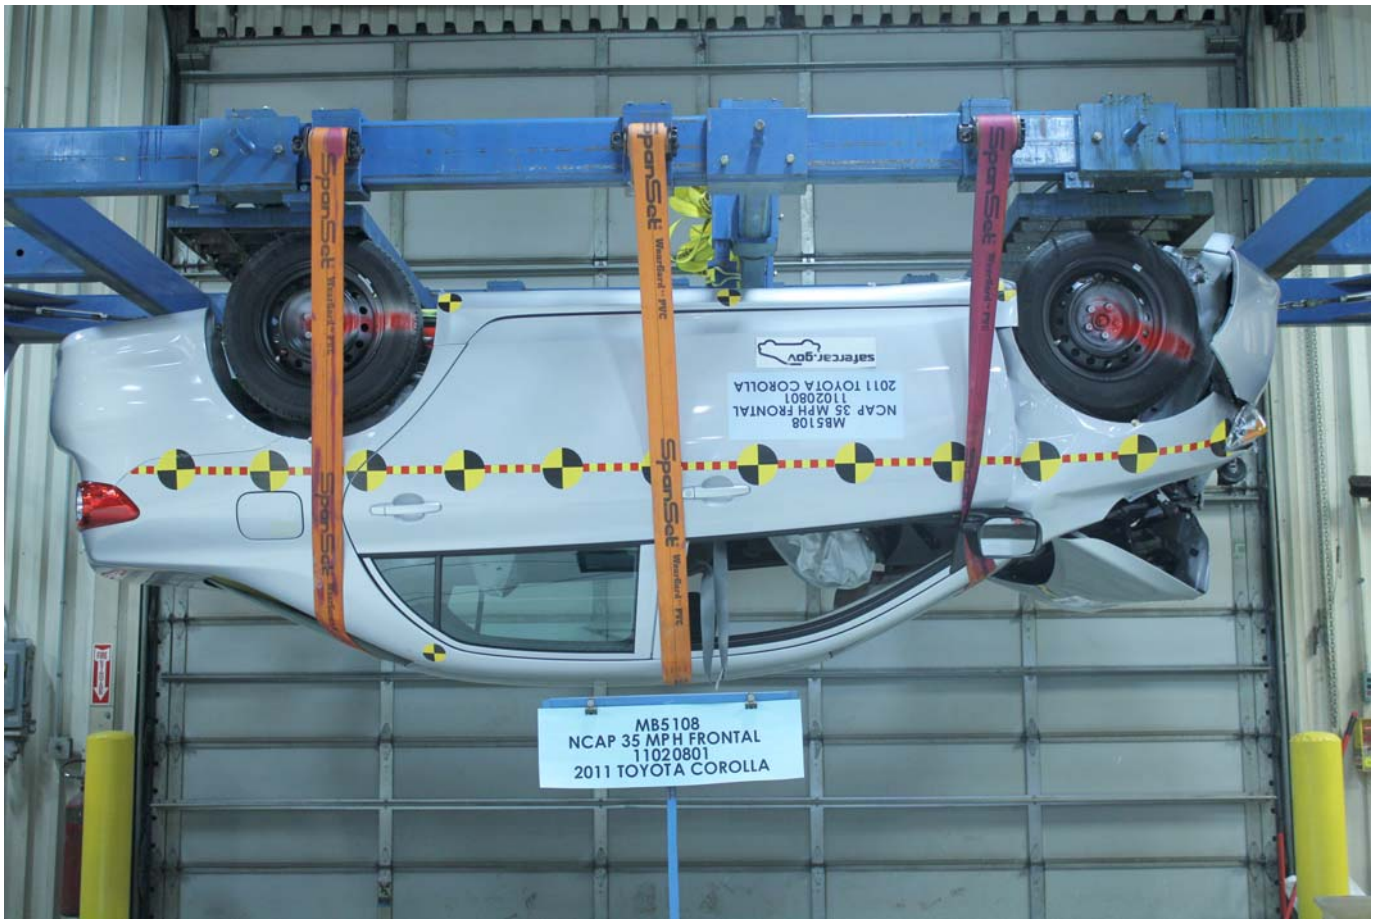
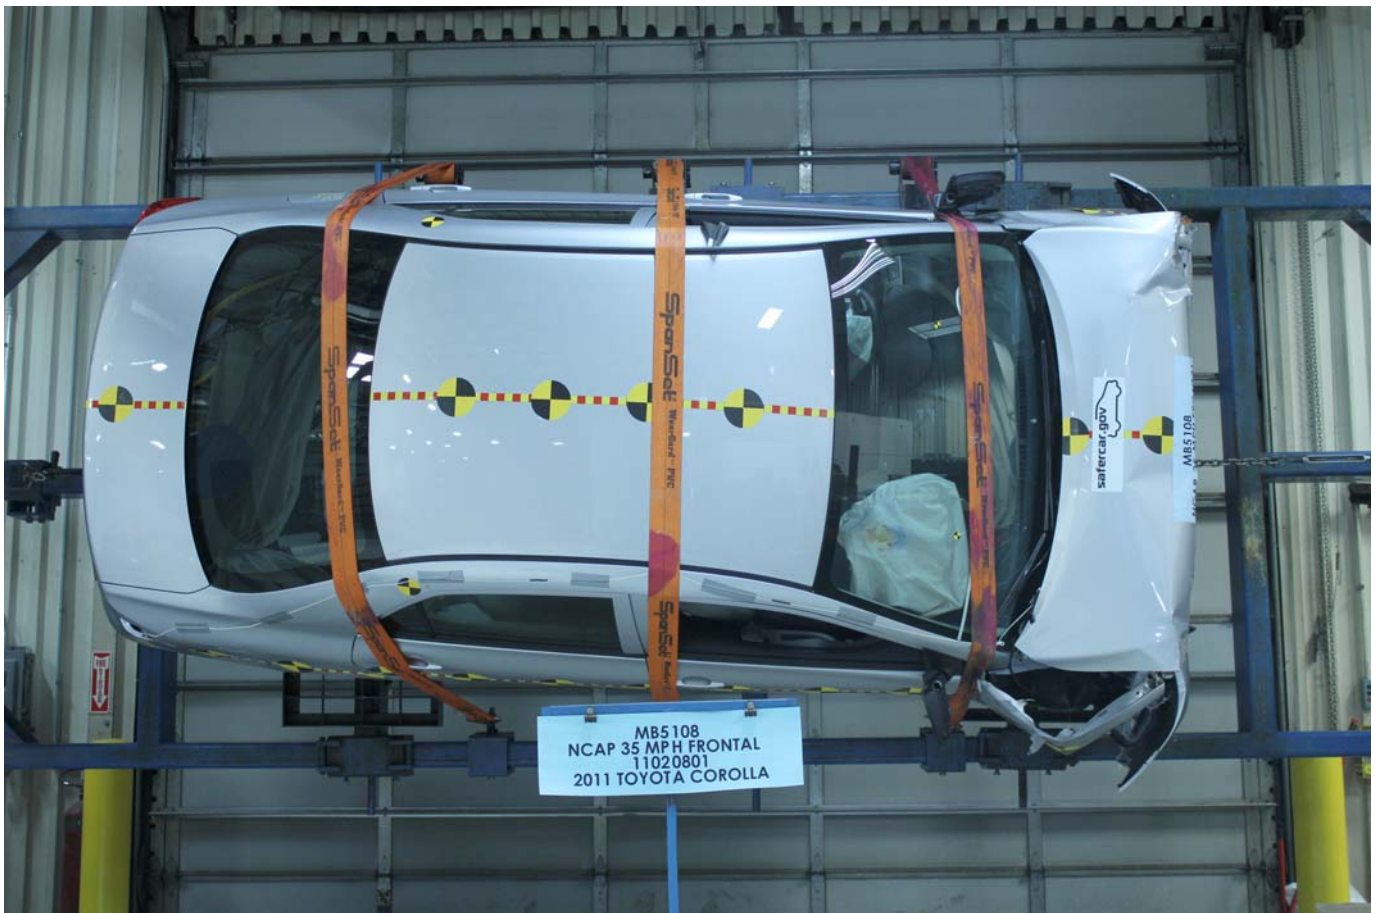
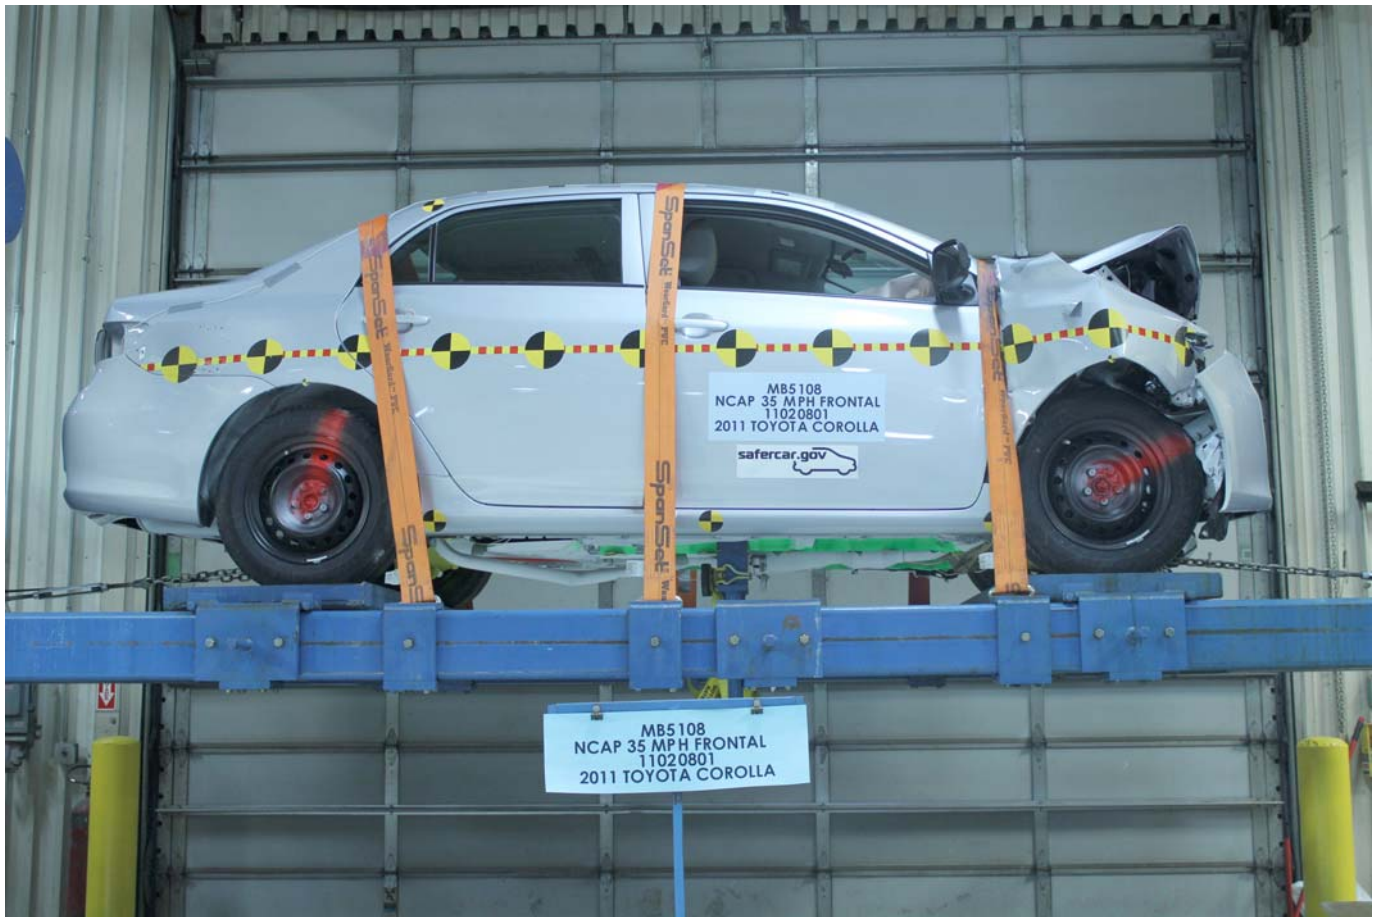
Vehicle at 0 Degrees on Static Rollover Device

Vehicle at 90 Degrees on Static Rollover Device

Vehicle at 180 Degrees on Static Rollover Device

Vehicle at 270 Degrees on Static Rollover Device

Vehicle at 360 Degrees on Static Rollover Device
